Screening Site Inspection
Final Report

Decatur/Barder & Spawr Landfill
ILD 984 766 378
September 30, 1994

B&V Waste Science and Technology Corp.
101 North Wacker Drive
Suite 1100
Chicago, Illinois 60606

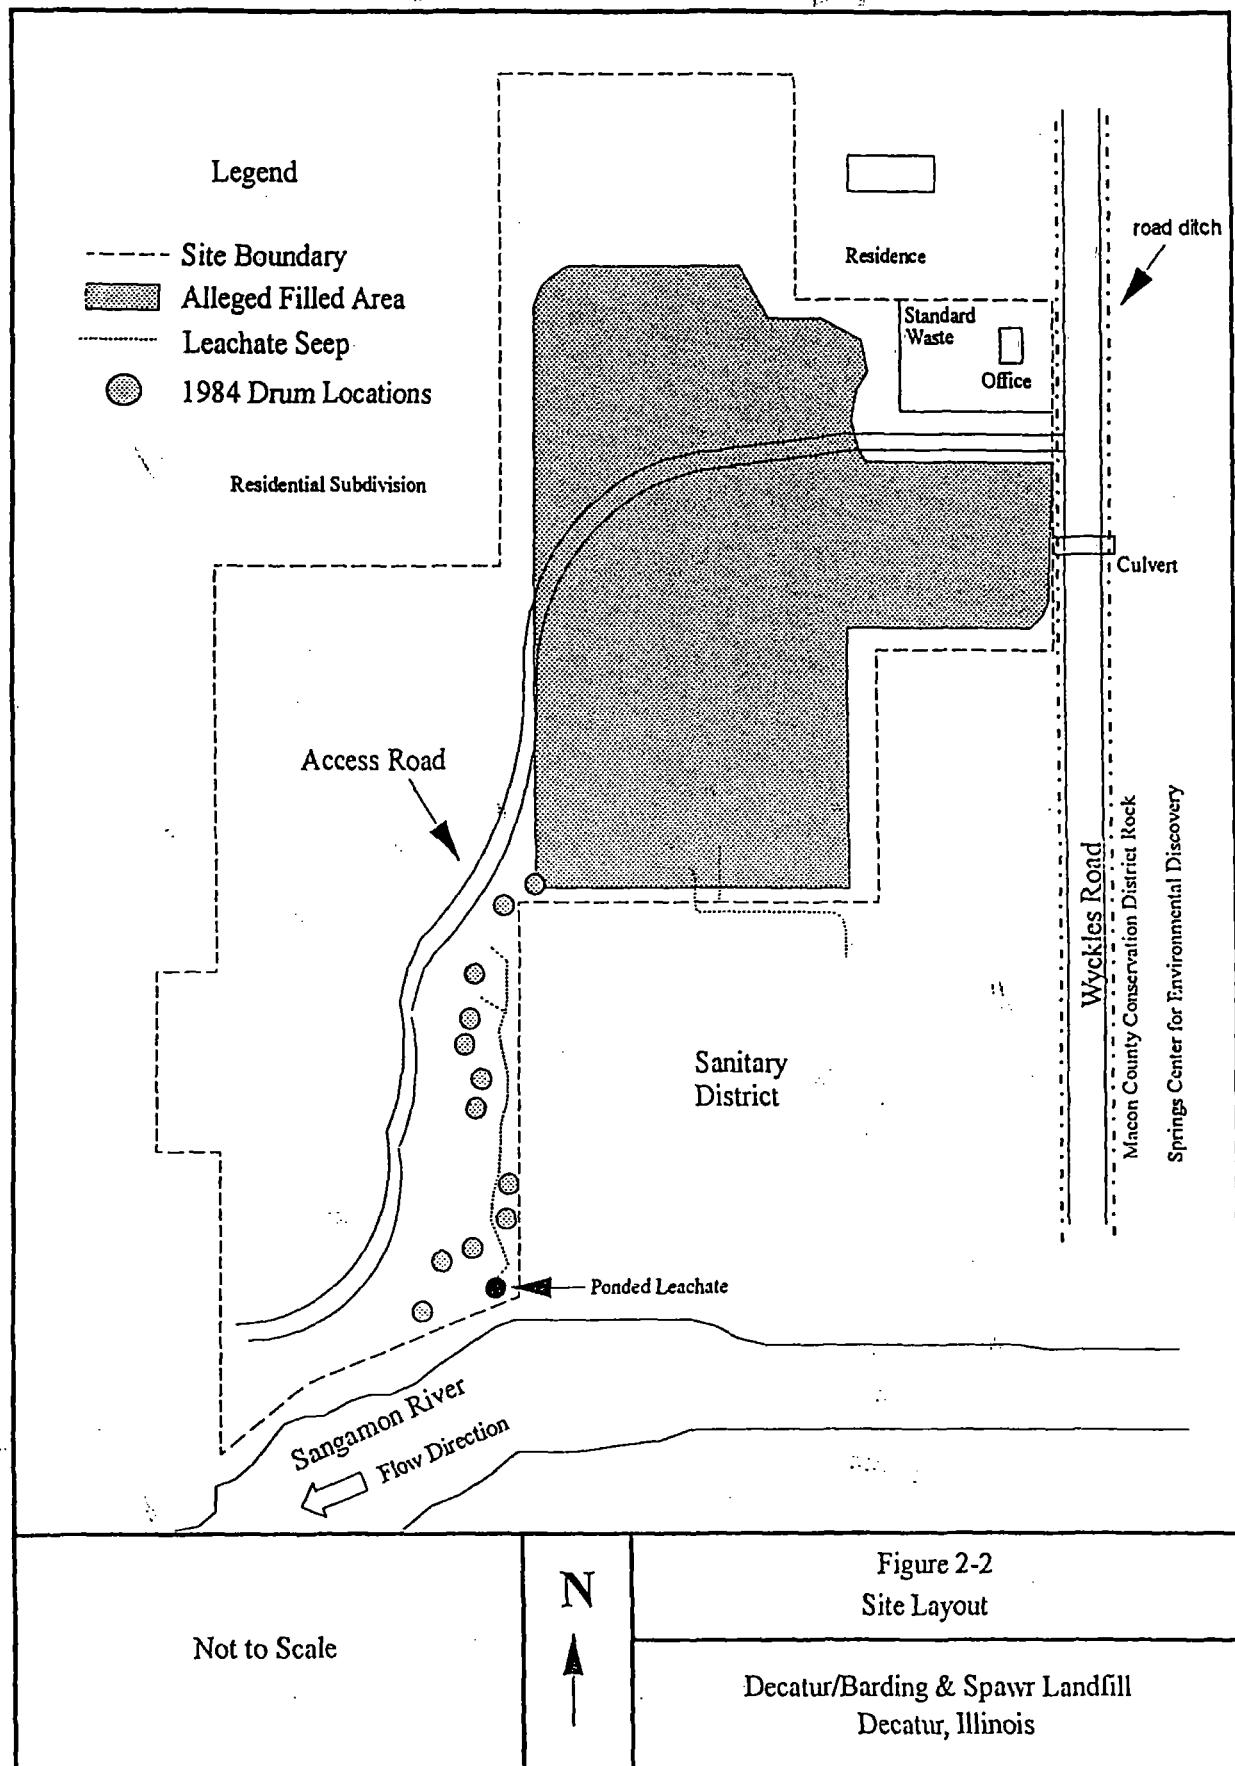
The Barding & Spawr site is located on Wyckles Road, south of US Route 36, just west of Decatur, Illinois. Most of the site is in the northeast quarter of Section 24, Township 16 North, Range 1 East, in Macon County. Figure 2-1 is a United States Geological Survey (USGS) site location map; Figure 2-2 shows the site layout.

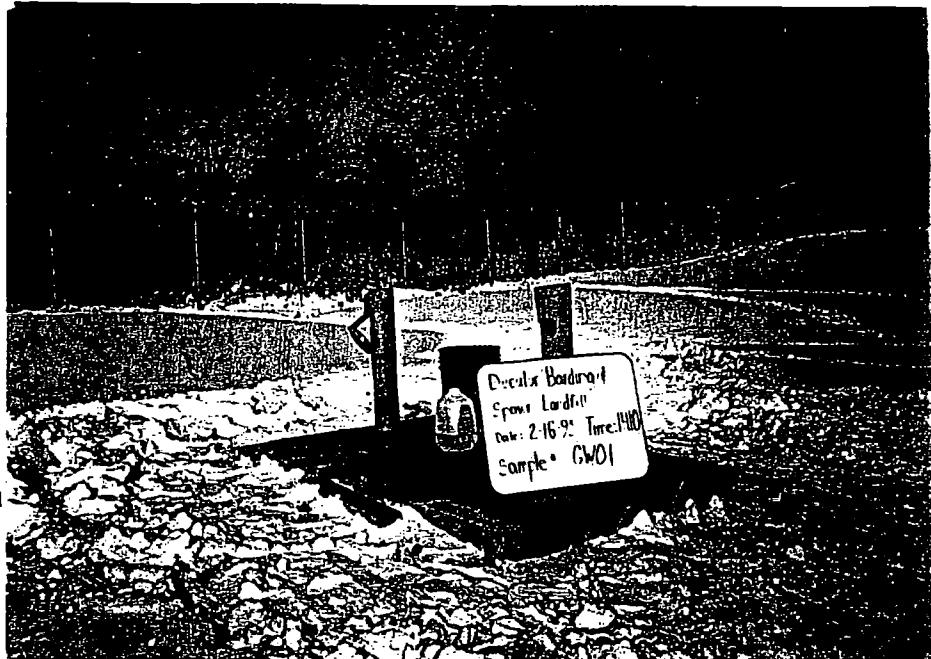
Description: Sanitary District monitoring well
G102 in center of photograph. Sample GW02
(not shown) was collected from well G102.

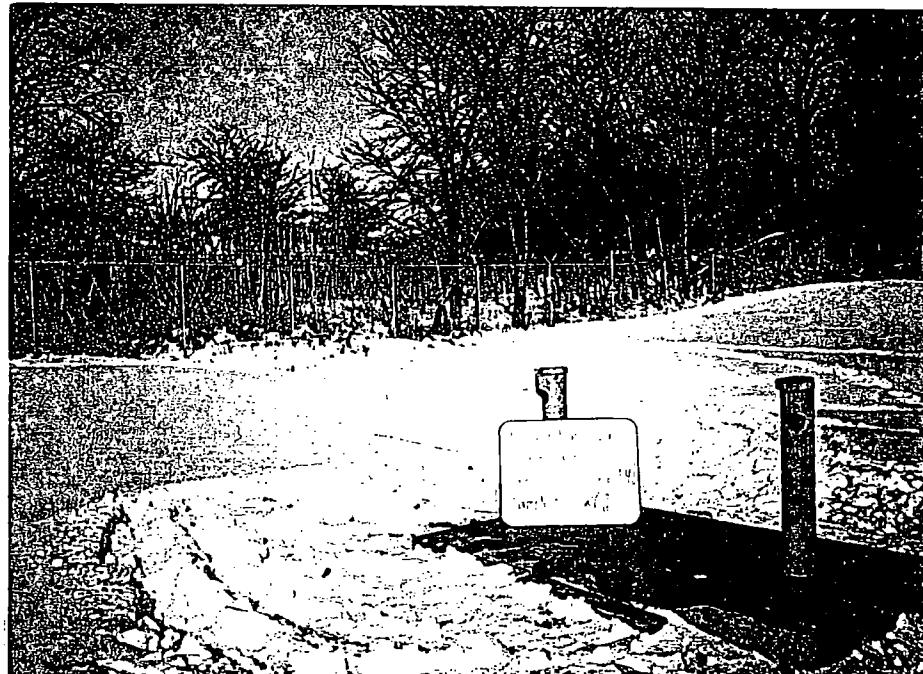
Description: Sanitary District monitoring well
G103 in center of photograph. Sample GW03
(not shown) was collected from well G103.

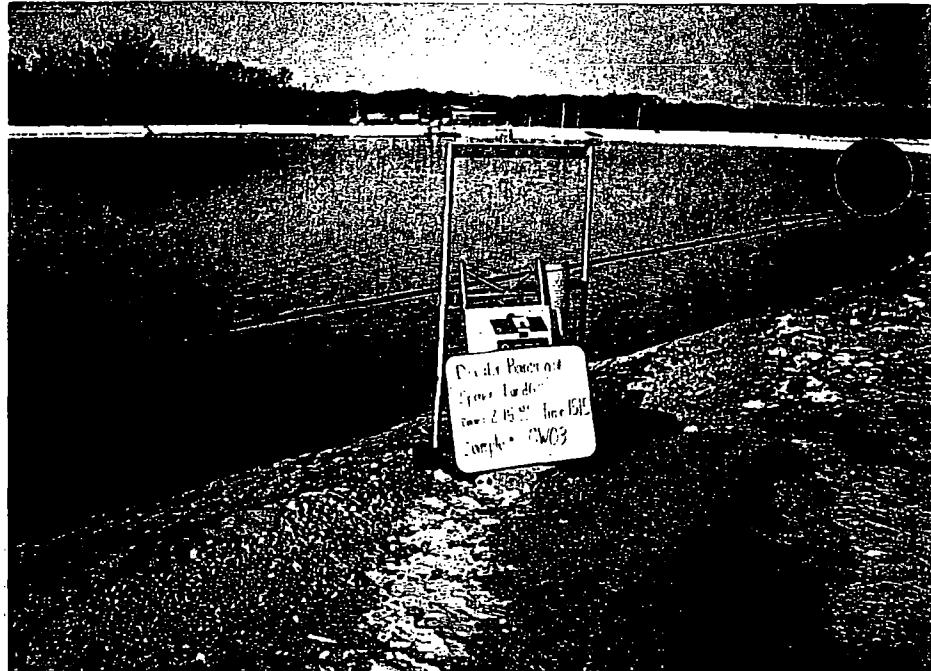
Description: Sanitary District monitoring well
G103 in center of photograph. Sample GW07
(not shown) was collected from well G103.
Placard is incorrectly labeled Sample GW04.

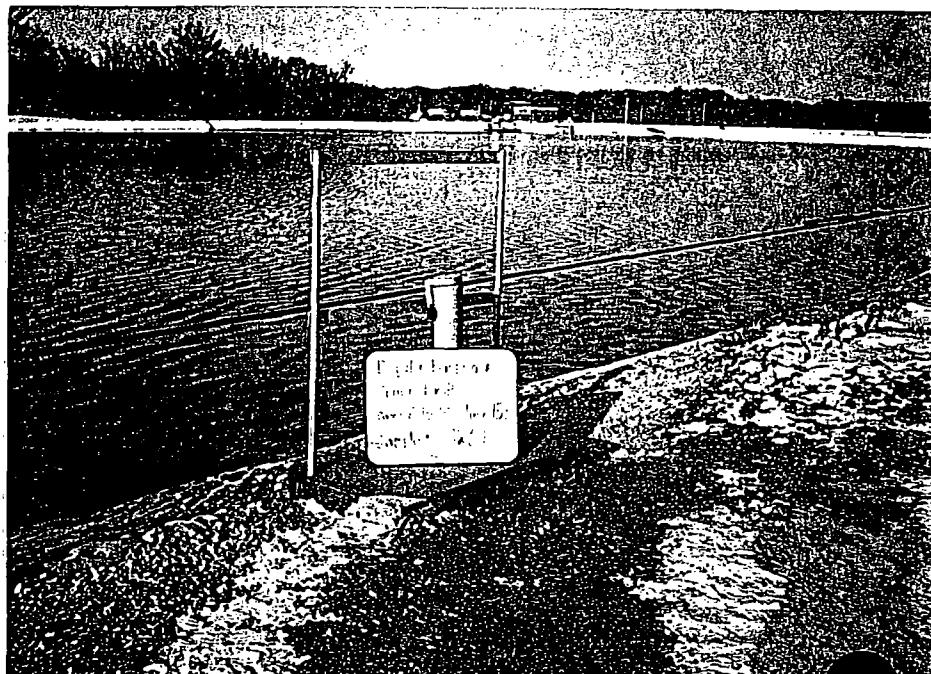
Description: Sanitary District monitoring well G104. Sample GW04 (not shown) was collected from well G104. Placard is incorrectly labeled Sample GW05.

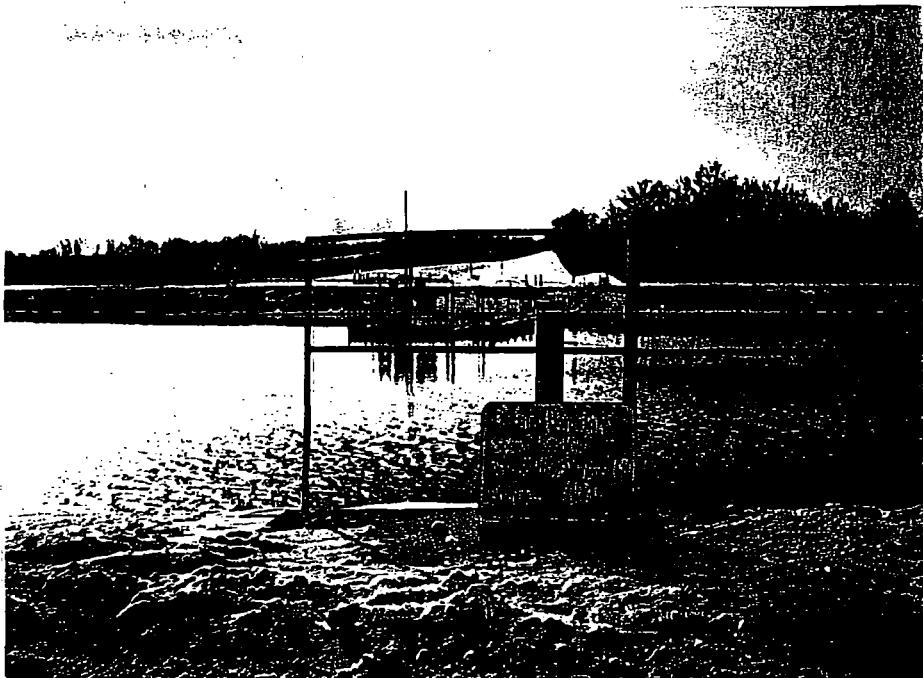
Description: Sanitary District monitoring well G101B in background. Sample GW05 (not shown) was collected from well G101B. Placard is incorrectly labeled Sample GW06.

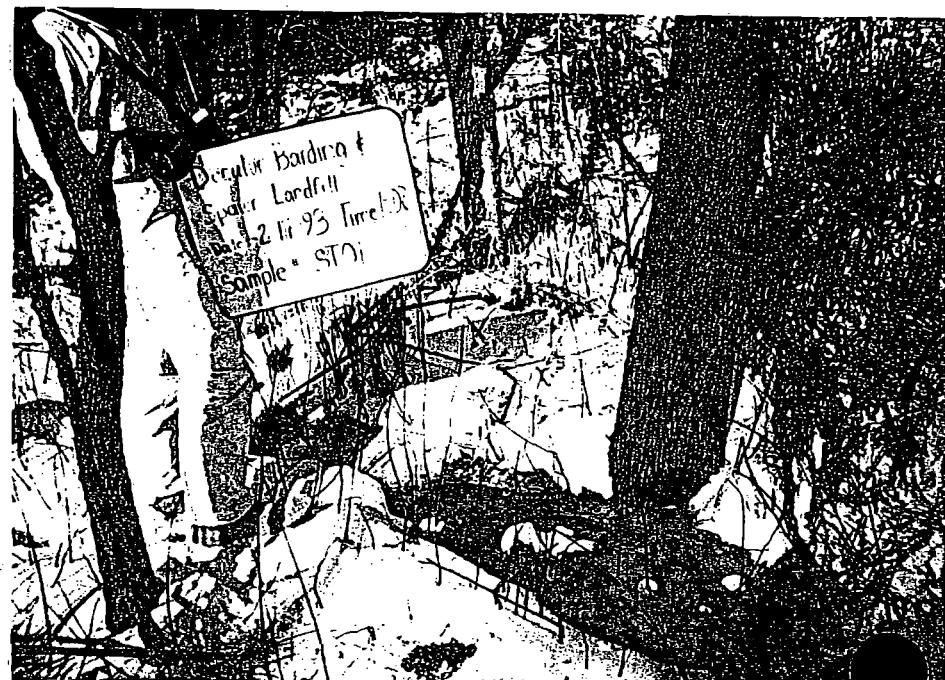
Description: Sample location of ST02. ST02
was collected below the red flag, below
standing water. The standing water appears to
be ponded leachate that drains to the ditch
behind and below the placard.

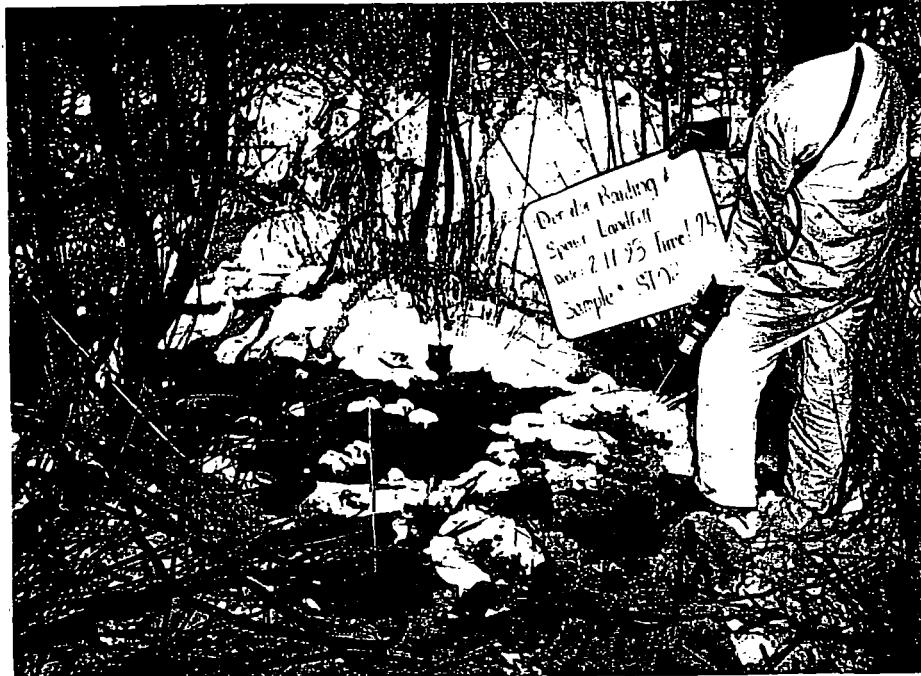
A background soil sample, SS04, was collected from the residence north of the site. This location was selected as representative of natural soil conditions in the area. Soil samples SS01-3 were collected on Barding & Spawr property in an area where dilapidated, empty drums are strewn across the ground surface.

Some of the drums found onsite in 1984 are still present. At the time of their discovery, nineteen 55-gallon drums were documented onsite. Some of the drums contained an unidentified liquid in 1984. About one dozen dilapidated and empty drums were observed onsite during the 1993 SSI sampling visit.

Description: Sample location of SS01. Note
the drums and refuse in the background.

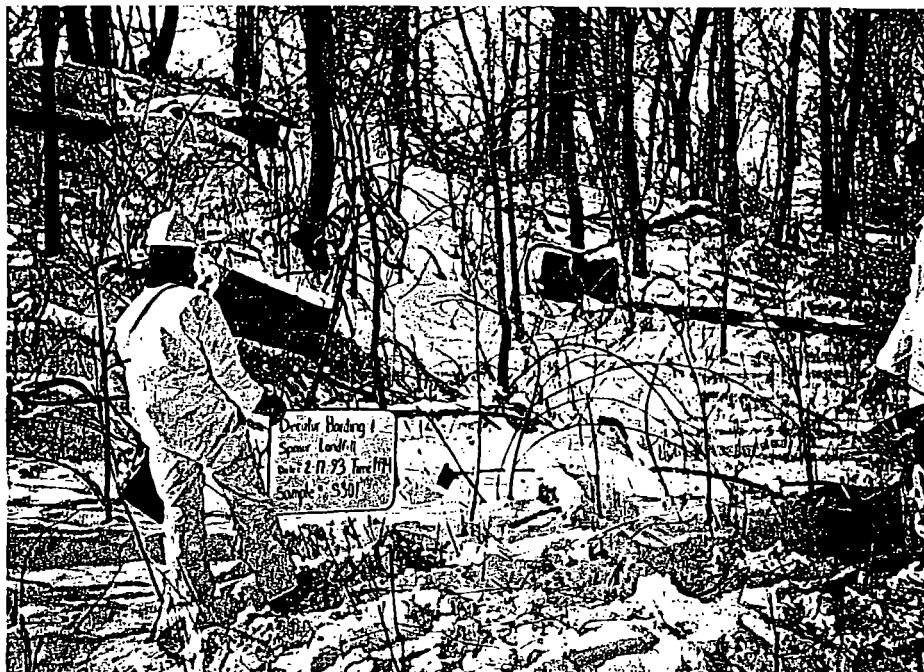
Description: Sample SS02 location. Note
refuse in the background and terrain.

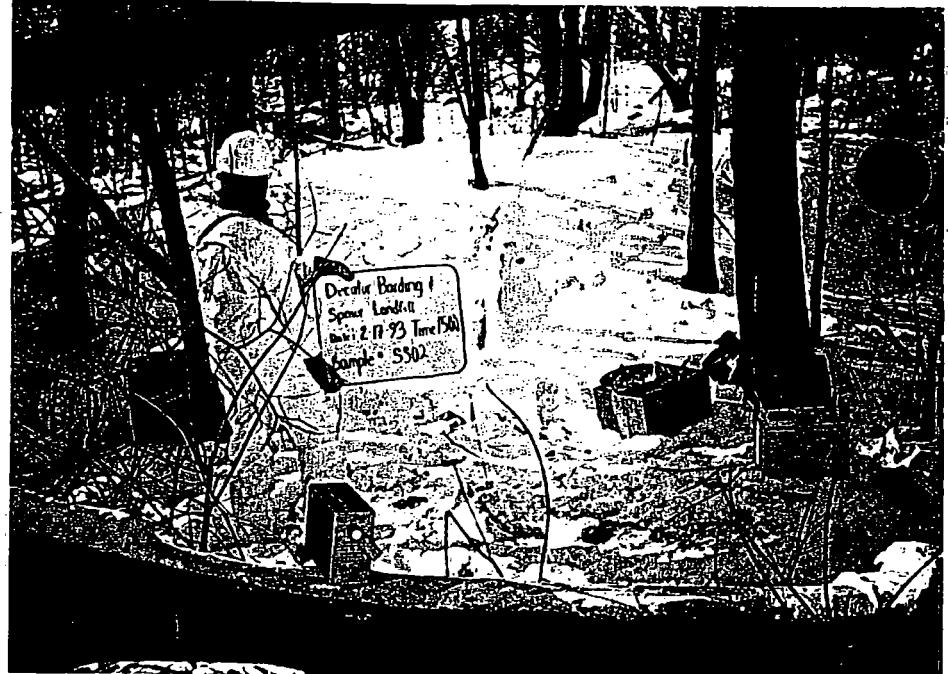
Description: Sample SS03 location.

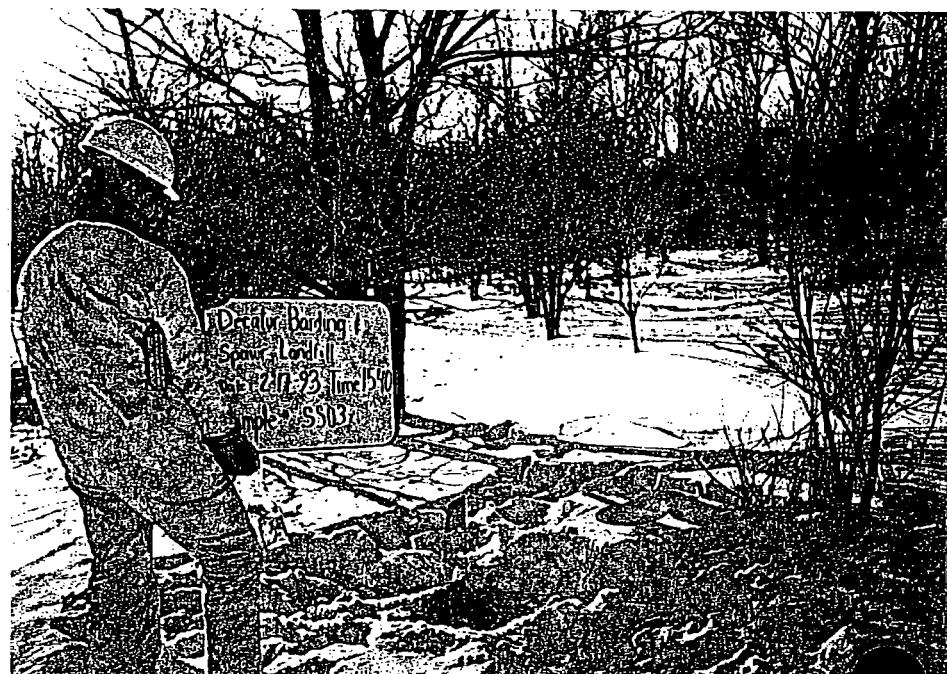
Description: Sample ST03 location. Drainage
is southerly, under the fence in background
and onto the adjacent Sanitary District.
